TEST REPORT

No. : XMIN191102824CCM

Sample Name : WOVEN VINYL FLOORING
Material : 94% PVC & 5% POLYESTER & 1% FIBREGLASS

ASTM D2859-16 Standard Test Method for Ignition Characteristics of Finished Textile Floor Covering Materials.

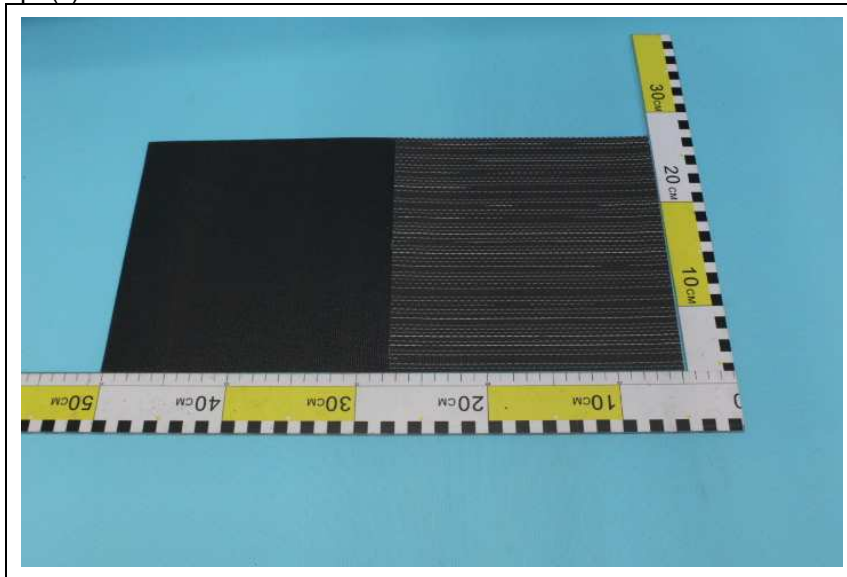
Specimen photograph(s):

Sample description	WOVEN VINYL FLOORING, Weight: 2.8 kg/m ² (see photo)
Conditioning	No cleaning procedure (AS per client's requirement)
	Cleaning with vacuum cleaner
	Dry at (105±2)°C, Duration: 2h
